Manhole Inspection Summary

Manhole # S53G__012MH

Insp Date: **9/15/09 1:11 PM**

Location Address: **328 S.Bouldin St.**

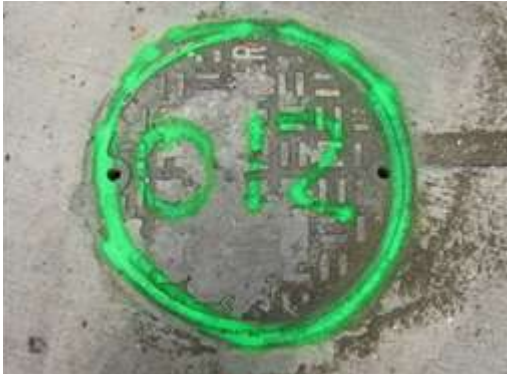
Miscellaneous

MH Lid

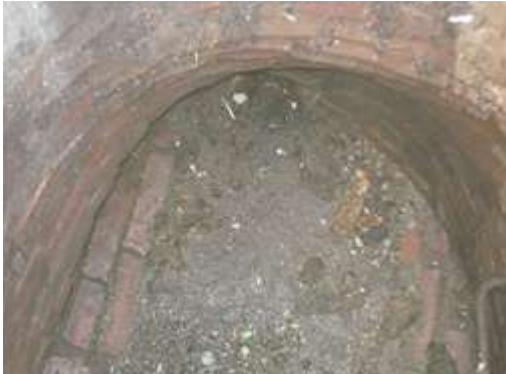
Miscellaneous

channel debris

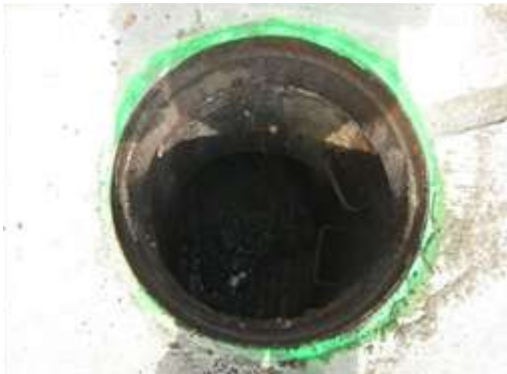
Miscellaneous

Frame View

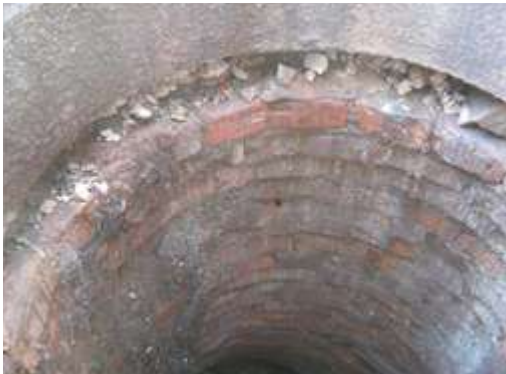
Defect 1

Condition: ☐ Sound ☐ Cracked ☐ Root Intrusion ☐ Loose Brick ☒ **Deteriorated**

Infiltration: ☐ None ☒ **Joint** ☐ Cracks ☐ Mortar ☐ Roots ☐ Wall

deteriorated chimney with joint infiltration

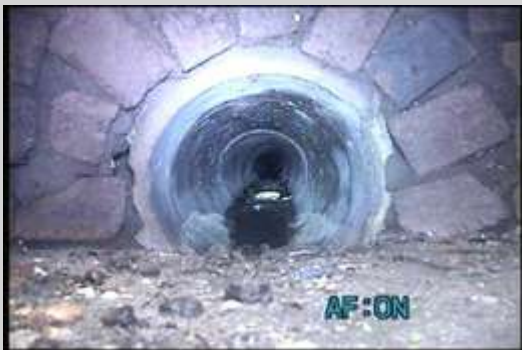
12 O'Clock Outflow

8 in. Circular Gravity Sewer
Pipe Out @ 12 O'Clock

Infiltration: **None** Pipe Seal Cond: **Sound**

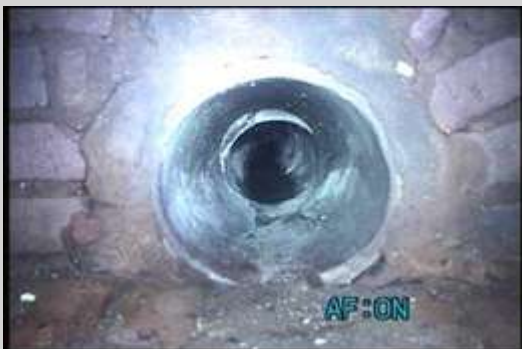
6 O'Clock Outflow

8 in. Circular Gravity Sewer
Pipe Out @ 6 O'Clock

Infiltration: **None** Pipe Seal Cond: **Sound**
